**LTPP Seasonal Monitoring
Program**
Site Monitoring Suspension
Status Report
Section 100102
Ellendale, Delaware

SEASONAL MONITORING PROGRAM SUSPENSION STATUS REPORT

DELAWARE SECTION 100102

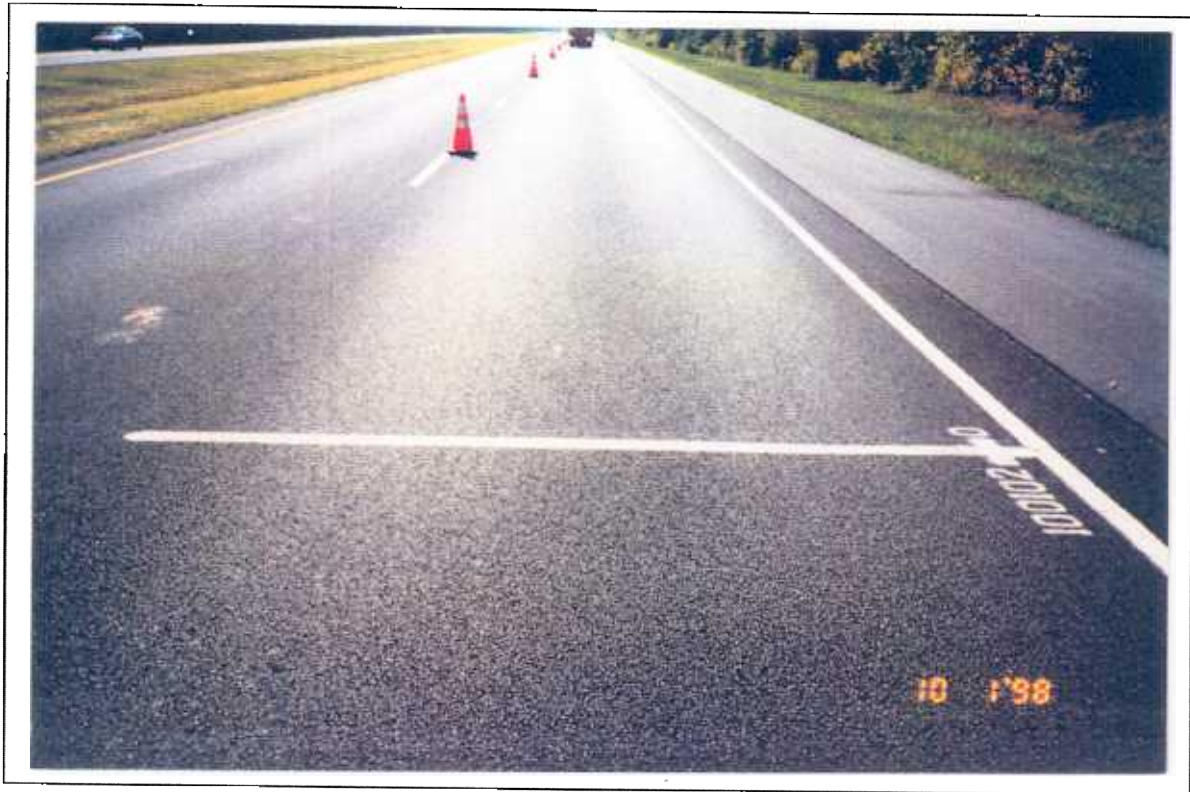
Pavement Condition, Seasonal Site 100102, October 1998, Pre Suspension Activities

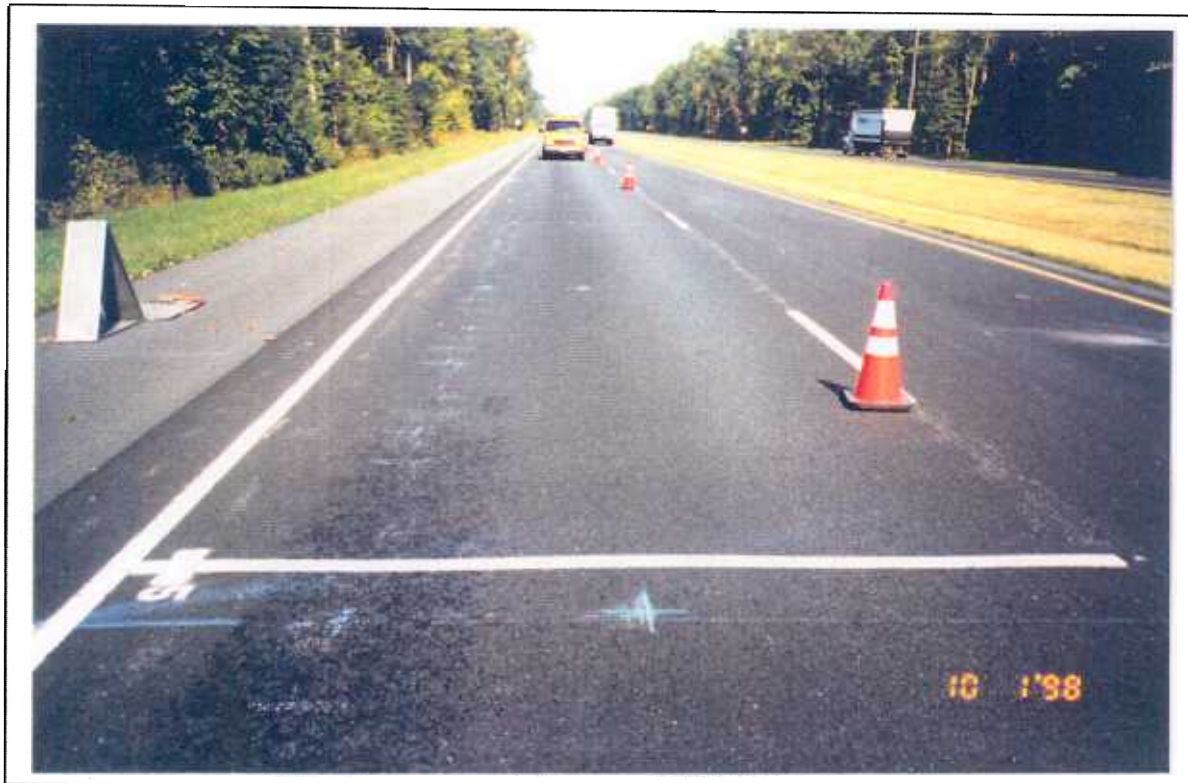
Pavement Condition, Seasonal Site 100102, October 1998, Pre Suspension Activities
